# Suspension and steering

## 61: Replacing control arm (steel) and/or control arm bushings, D5252T MSA 15.7

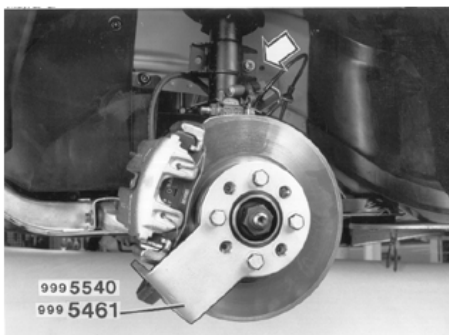
Applies to cars of model years 97-98:

Raise the car.  
Remove the wheel.  
Install counterhold [999 5461](#) .  
Detach the drive shaft end at the hub Tap in the shaft end approximately 10-15 mm. Use a plastic or copper mallet or use puller [998 5434](#) together with [999 5461](#) .

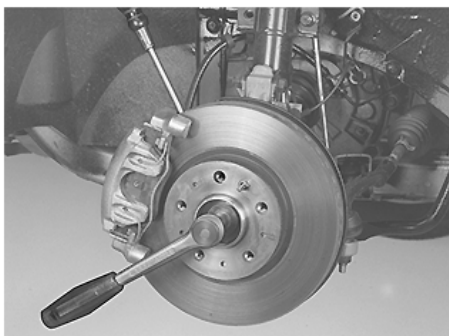
Applies to cars of model years 99-00:

Raise the car.

- Remove:
- the wheel
  - the drive shaft screw.

Use a screwdriver as a counterhold.  
Detach the drive shaft end at the hub Tap in the shaft end approximately 10-15 mm. Use a rubber or copper mallet.

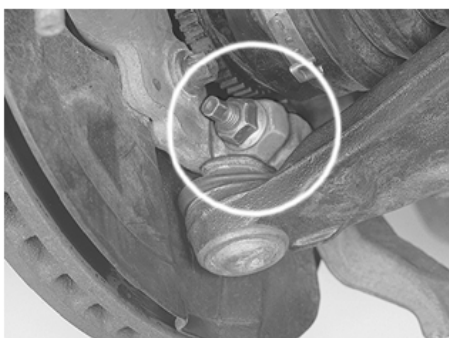
#### Cleaning around the ball joint

Blow clean around the ball joint with compressed air.  
Generously spray the ball joint and the screw and nut retaining the ball joint using rust penetrator.

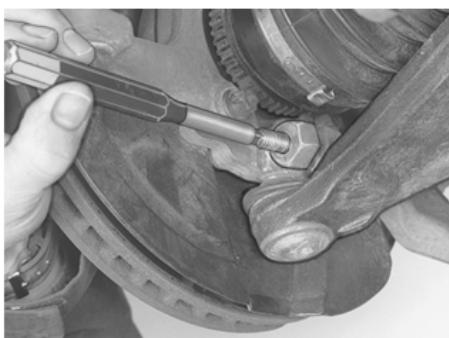
#### Removing the ball joint from the wheel spindle

**Note!** Do not insert a screwdriver or punch between the "ears" on the wheel spindle.

If the screw has rusted solid, slacken off the nut a few turns.  
Knock the screw so that it loosens.  
Remove the screw and the nut.  
Spray the ball joint with rust penetrator again.
